Home Inspection Report for:

Prepared by: José Negrón, PE

2/17/2022

INSPECTION REPORT

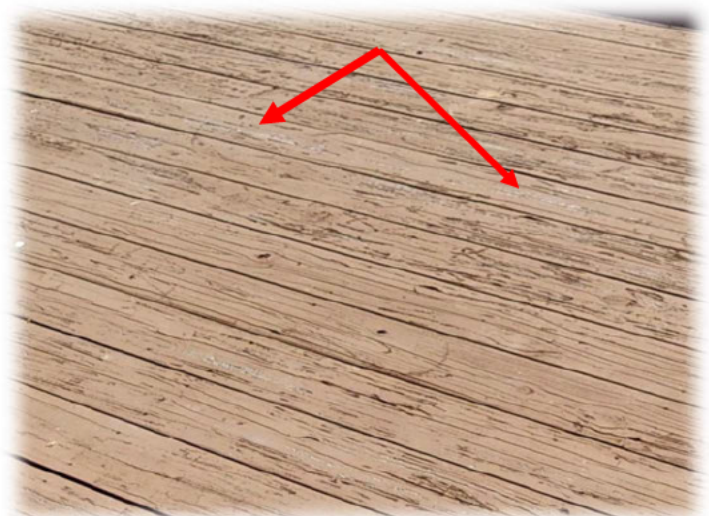
Photo #4

The property has a medium-sized front yard and a large backyard. The first-floor terrace, the pool, power generator, and water tanks are all located in the backyard (Photo #1 & Photo #2). There is also a grass area on the east side (Photo #3). There are several damaged planks on the terrace area that seem to stem from moisture (Photo #4).

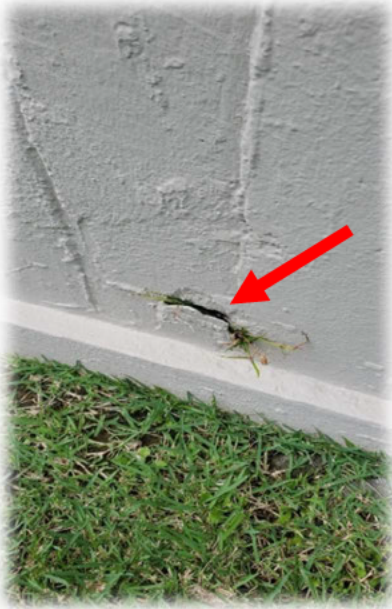
Photo #5

The east wall has a patch with some vegetation growing out of it (Photo #5). There are also some signs of minor water damage (Photo #6). One of the ceramic tiles is broken (Photo #7). The terrace is flooded. The water pump that removes water from the terrace can't be operated due to an electric fault on the receptacle. The owner states that the pump is fully functional, however, this could not be verified (Photo #8). The infinity pool is in good conditions (Photo #9).

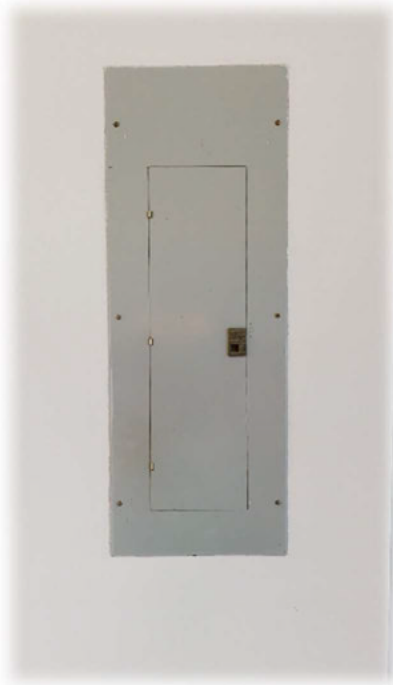
Photo #11

The electric meter is located on the east wall of the property. The main panel, located on the dining room wall, has an uncovered breaker slot (Photo #11). This can be fixed by simply installing a breaker cover or a circuit breaker, even if it is not wired. The property has an electric charger for electric vehicles. The charger is connected to the same electric panel as the pool water heater. This is not up to NEC standards, since the ampacity rating of the wires is lower than the installed capacity. To counter potential overload in the wire, a breaker fastener was installed (Photo #12). This is a temporary solution; however, it is still not up to code. The main valve could not be found on the property.

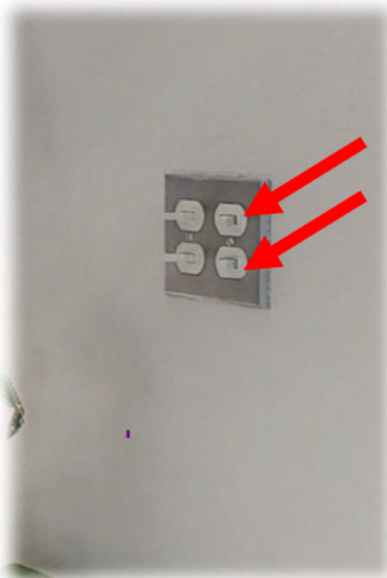
Photo #23

The entrance of the property leads straight to the dining room (Photo #21 & Photo #22). There are two switches on the left side and two switches on the right side that do not seem to be connected to anything (Photo #23). A window operator is slightly damaged but works (normal wear and tear) (Photo #24). The cover of a communication outlet is missing (Photo#25).

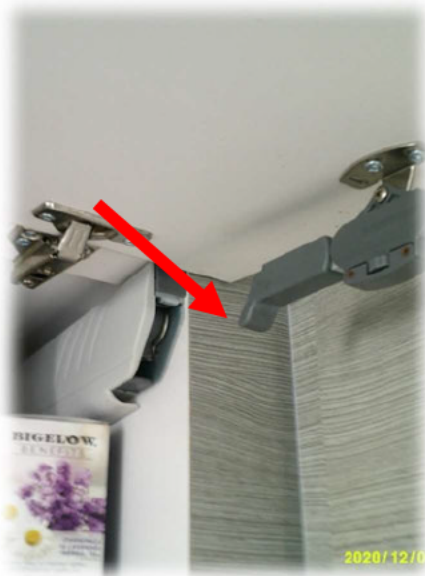
Photo #31

The kitchen (Photo #29 & Photo #30) is located right next to the dining room (east side). It is equipped with a double door refrigerator, a microwave with inverter technology, an oven, a gas stove and a filter in the sink. These appliances were tested and all of them work properly. There is a broken hinge (Photo #31) and two hinges that make a cracking sound when opening the doors (Photo #32 & Photo #33). These two hinges work properly though.

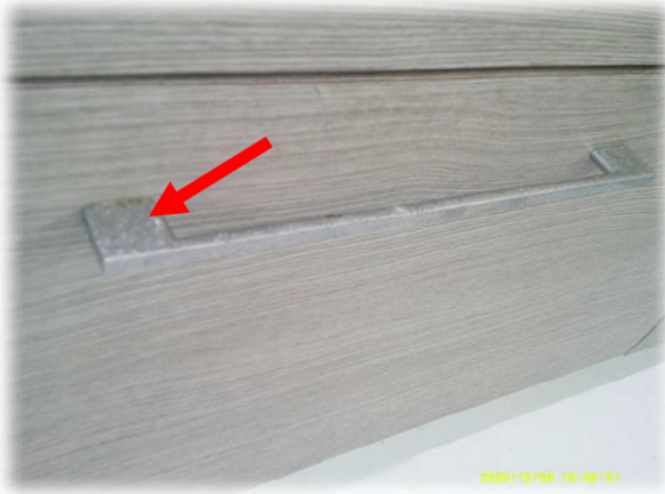
Photo #34

Handles on the shelf doors show signs of wear and tear, and might need paint to avoid rust or further degradation (Photo #34). There is one receptacle near the counter with no GFCI. GFCI replacement recommended (Photo #35).

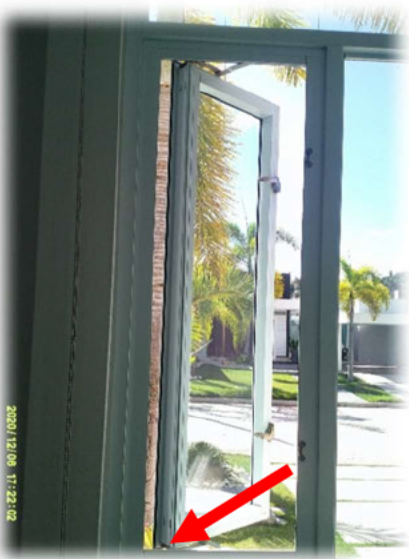
Photo #38

The family room is found west of the dining room. It is a large area divided in two smaller rooms labeled Family Room 1 and Family Room 2. Family Room 1 (Photo #36 & Photo #37) has a glass window that gets a little stuck and is hard to operate (Photo #38). The PVC furniture on the wall has a squeaky door (Photo #39).

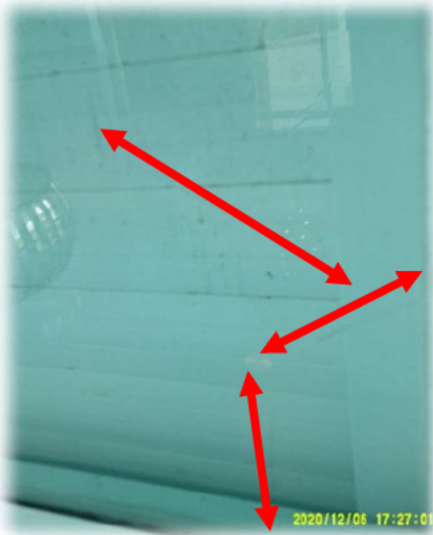
Photo #42

Family Room 2 (Photo #40 & Photo #41) has a glass panel that is cracked on the left lower corner (Photo #42). There are two sliding doors that could not be opened (Photo #43). Functionality could not be determined. It is possible that a different key opens them but the owner has no knowledge of this and never opens those two doors. Some orange stains were noticed on the top corner, where a cable runs across (Photo #44). Water damage is possible but no moisture was detected in the wall below. Further assessment recommended.

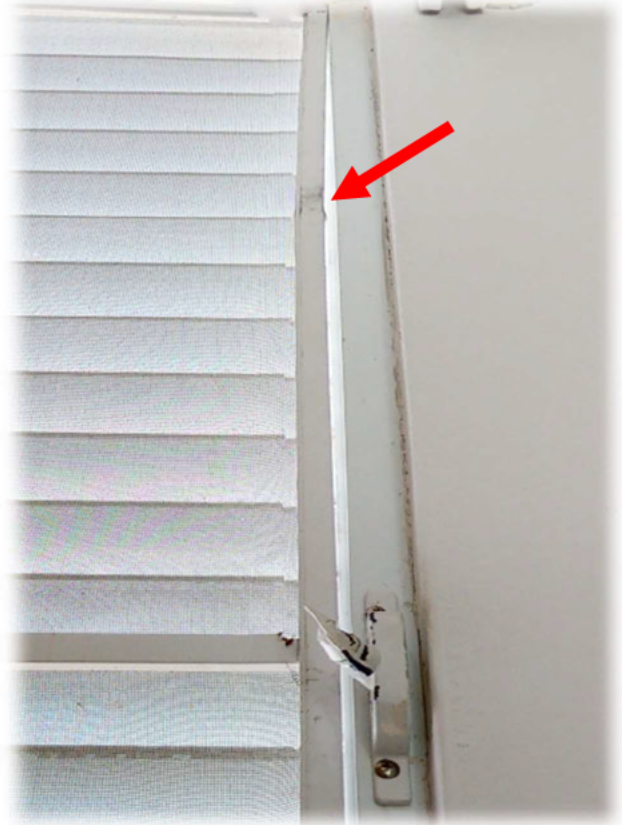
Photo #52

The stairs (Photo #51) leading to the second floor are in good conditions. There is a window at the top that is missing a clip (Photo #52) and the operator is showing signs of wear and tear (Photo #52).

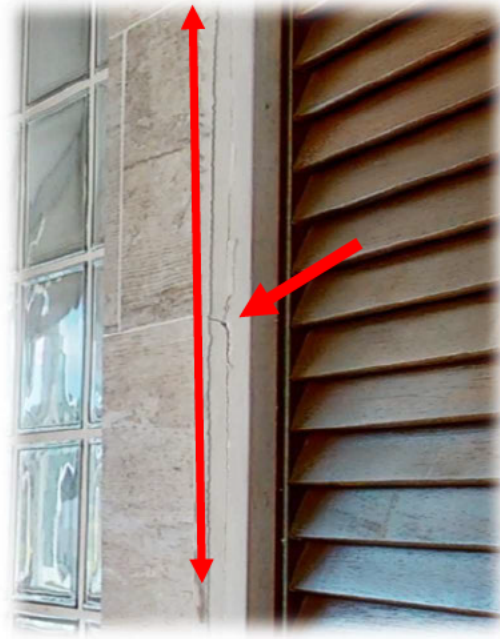
Photo #54

The hallway (Photo #53) has a closet door with a frame that has some plaster delamination (Photo #54). The wooden door is slightly slanted but works perfectly (Photo #55). There is another closet at the end of the hallway (Photo #56) and its door gets stuck. It might need lubrication.

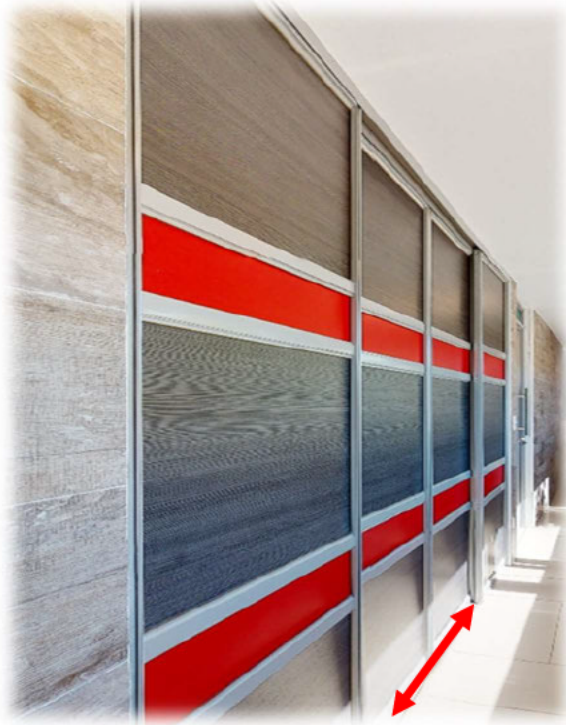
Photo #57

The laundry room door (Photo #57 & Photo #58) gets derailed easily. The cabinet door handles are rusted (Photo unavailable).

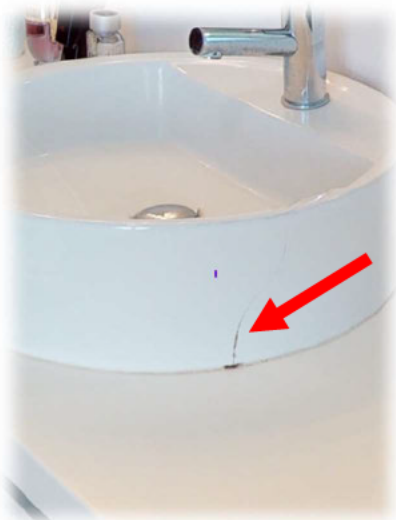
Photo #61

All bedrooms are located on the second floor. Bedroom #1 (Photo #59 & Photo #60) is the first room seen from the end of the stairs. The closet has a wooden shelf broken (Photo unavailable). The bathroom has a cracked wash basin (Photo #61). The wooden door is missing some fascia on one side and has water marks on the other, possibly due to flooding (Photo #62). Water pressure is reduced when opening several faucets while operating the shower and toilet flush. The bidet has low pressure and doesn't produce an upstream (Photo #61). There is also a receptacle behind the towel rack that does not have GFCI.

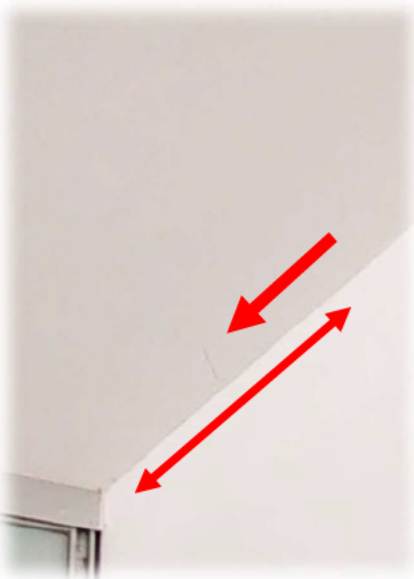
Photo #66

Bedroom #2 (Photo #64 & Photo #65) has a several hairline cracks on the ceiling, to the left side of the closet (Photo #66). One of them should be monitored. Several window operators appear worn out (Photo #67). There is one receptacle that could not be checked because it was behind the dresser (Photo #68).

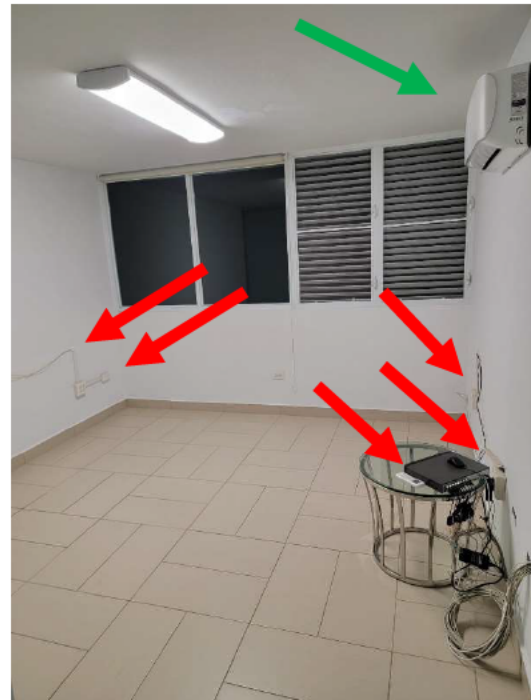
Photo #72

Bedroom #4 has the security camera equipment on a table (Photo #71 & Photo #72). The system's wires are loose and should be run through conduit (Photo #72). There are two receptacles with open ground and two external outlets with loose wiring. These should run through proper conduit (Photo #72). Communication outlet is missing a dead cover.

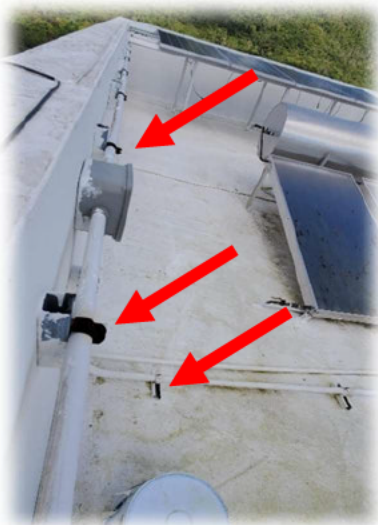
Photo #75

The roof (Photo #73 and Photo #74) has a solar panel array, several AC units, a solar water heater, and water tanks. The C-clips holding the water and electrical tubes are rusted (Photo #75). There are water marks below the solar panels, however, no moisture was detected inside the property (Photo #76). There is a water bubble in one of the walls (Photo #77).
