Home Inspection Report for:

Prepared by: José Negrón, PE

2/17/2022

INSPECTION REPORT

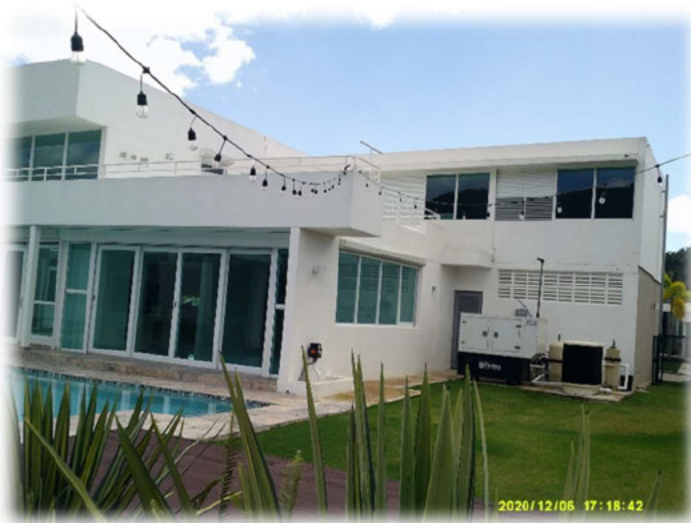
Photo #1

The property has a medium-sized front yard and a large backyard. The first-floor terrace, the pool, power generator, and water tanks are all located in the backyard (Photo #1 & Photo #2). There is also a grass area on the east side (Photo #3). There are several damaged planks on the terrace area that seem to stem from moisture (Photo #4).

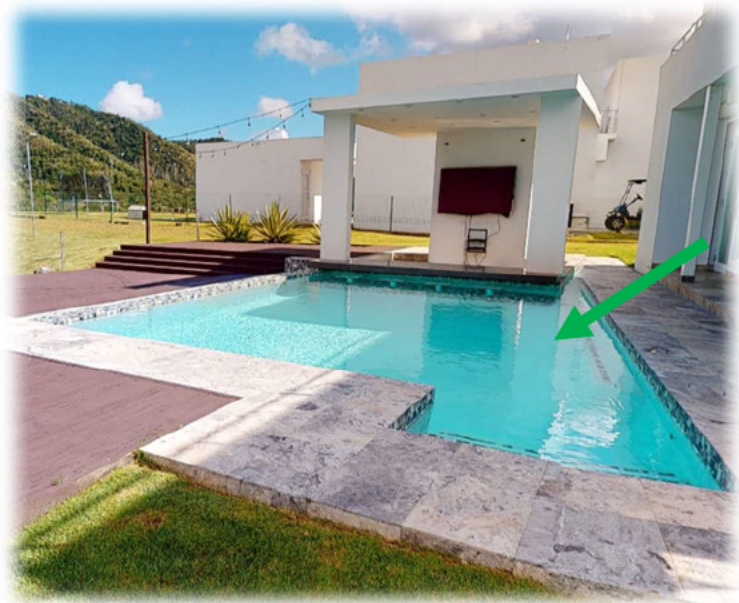
Photo #9

The east wall has a patch with some vegetation growing out of it (Photo #5). There are also some signs of minor water damage (Photo #6). One of the ceramic tiles is broken (Photo #7). The terrace is flooded. The water pump that removes water from the terrace can't be operated due to an electric fault on the receptacle. The owner states that the pump is fully functional, however, this could not be verified (Photo #8). The infinity pool is in good conditions (Photo #9).

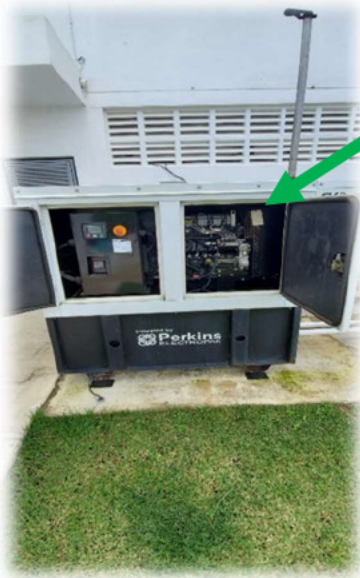
Photo #13

The property is equipped with a 20kW Perkins Electropak diesel generator in good conditions (Photo #13). It is connected via automatic transfer switch to the secondary side of the main breaker. It was turned on during the inspection. There are solar panels installed on the roof (Photo #14) and a Tesla battery installed in the dining room as a back-up (Photo #15). There's a solar panel inverter in the roof that is not connected to anything. It might have been decommissioned and left there (Photo #16). There are also 12 security cameras installed throughout the property (Photo #17).

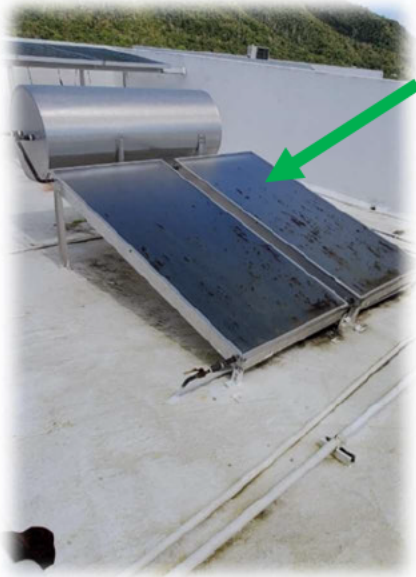
Photo #18

The property has a working solar water heater installed on the roof (Photo #18). There is also an electrical pool water heater right next to the power generator (Photo #19). The property has a water pump with two 300-Gallon water tanks as water reserve (Photo #20). These are located in the patio/backyard. There are also two smaller water tanks on the roof.

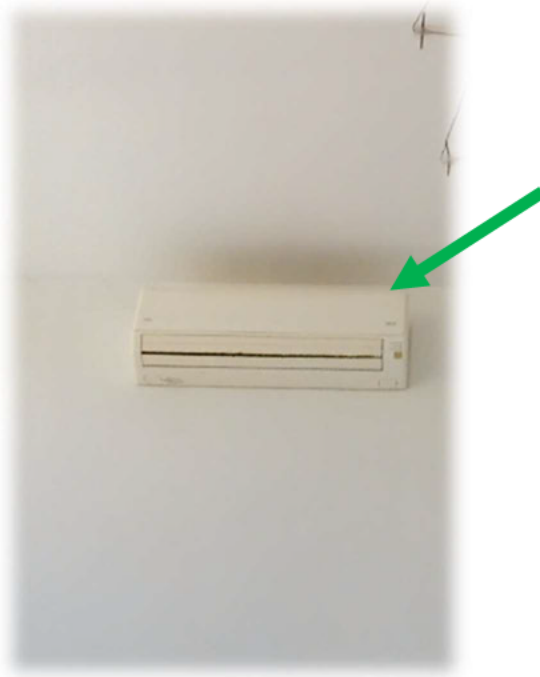
Photo #28

The space right next to the dining room is empty (Photo #26 & Photo #27). The only equipment in the room is the A/C (Photo #28). No damages or deficiencies found. That space is referred to as the living room in this report.

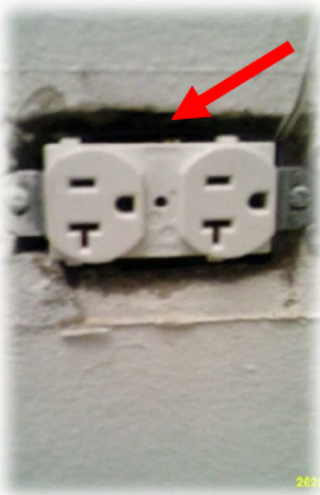
Photo #47

The garage (Photo #45 & Photo #46) is located on the west side of the property, accessible from the family room and from outside. Dead covers are missing on several outlets (Photo #47 & Photo #48). There is an electrical outlet with exposed wires on top of the east side parking space (Photo #49). There should be a lighting fixture or a dead cover in place. A metal panel on the west side wall is slightly loose (Photo #50).

- GFCI outlets are recommended for all exterior outlets, kitchen sink outlets and bathrooms outlets.*
- Three faulty receptacles, including the one meant for the sump pump.*
- Several outlets missing dead covers.*
- The panel feeding the pool heater and EV charger is not up to code.*
- The Main Panel is missing a breaker cover.*
- Low water pressure observed in the Master bedroom only.*
- Solar panels, solar heater, and diesel generator in good conditions.*
- Security cameras work.*
- Water tanks and pump in good conditions.*
- All A/C units work.*

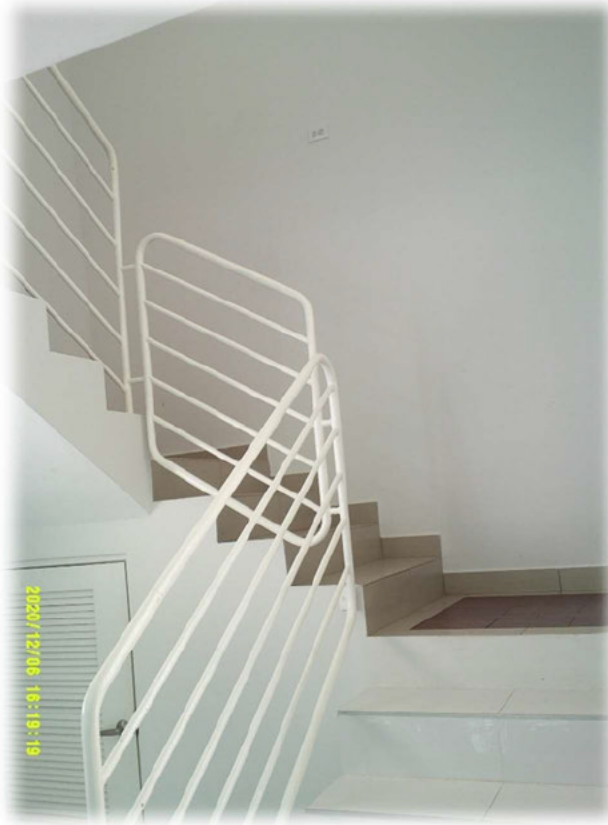
Photo #51

The stairs (Photo #51) leading to the second floor are in good conditions. There is a window at the top that is missing a clip (Photo #52) and the operator is showing signs of wear and tear (Photo #52).

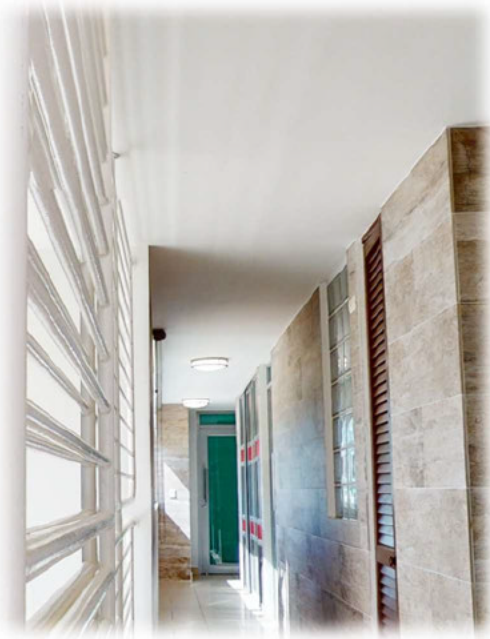
Photo #53

The hallway (Photo #53) has a closet door with a frame that has some plaster delamination (Photo #54). The wooden door is slightly slanted but works perfectly (Photo #55). There is another closet at the end of the hallway (Photo #56) and its door gets stuck. It might need lubrication.

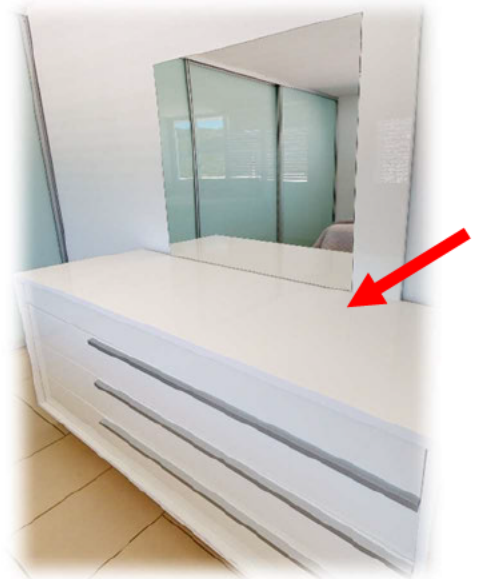
Photo #68

Bedroom #2 (Photo #64 & Photo #65) has a several hairline cracks on the ceiling, to the left side of the closet (Photo #66). One of them should be monitored. Several window operators appear worn out (Photo #67). There is one receptacle that could not be checked because it was behind the dresser (Photo #68).

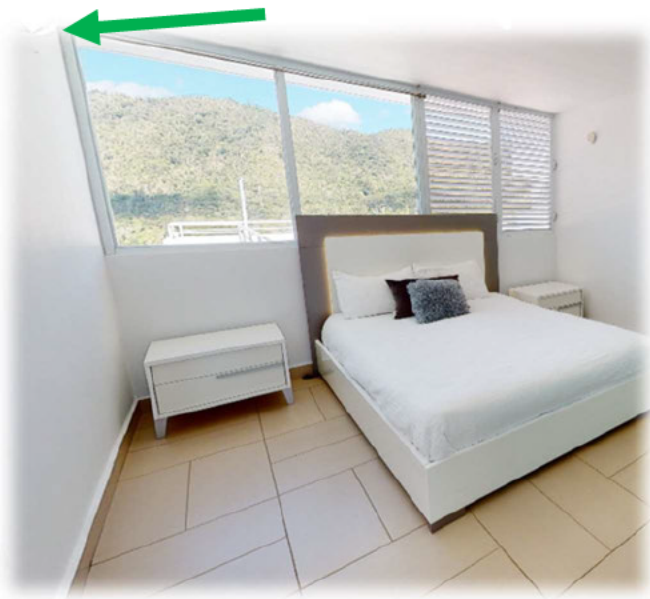
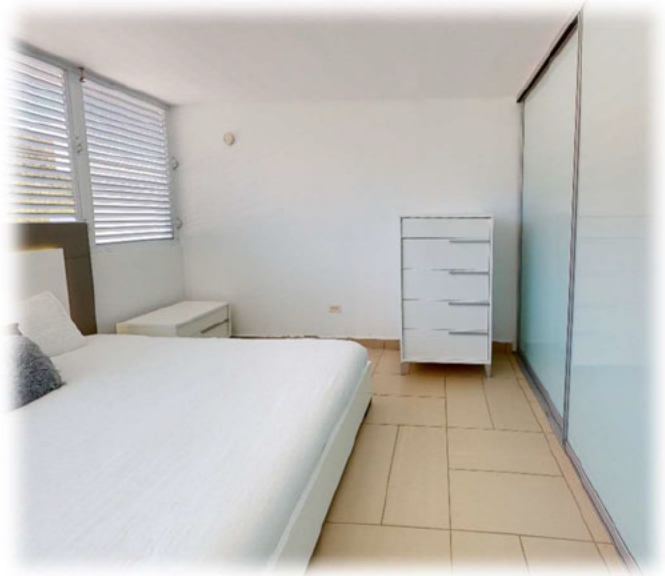
Bedroom #3 (Photo #69 & Photo #70) has no visible defect or damage.

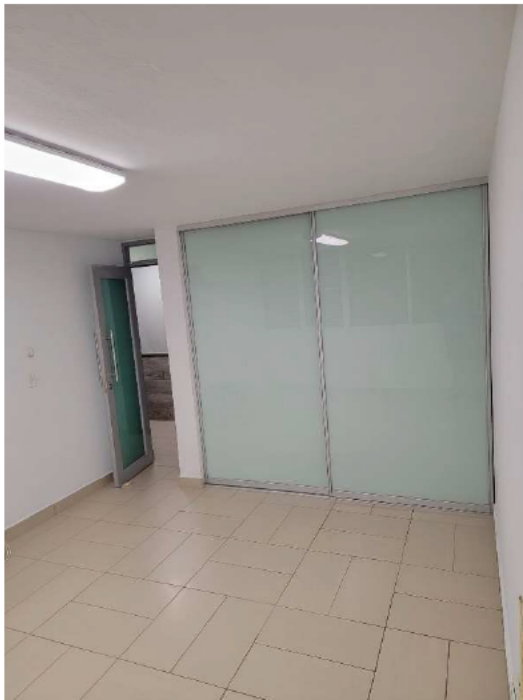
Photo #71

Bedroom #4 has the security camera equipment on a table (Photo #71 & Photo #72). The system's wires are loose and should be run through conduit (Photo #72). There are two receptacles with open ground and two external outlets with loose wiring. These should run through proper conduit (Photo #72). Communication outlet is missing a dead cover.

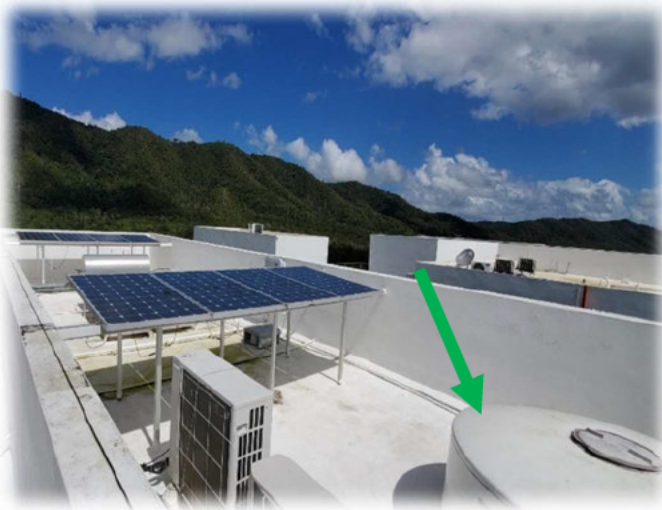
Photo #73

The roof (Photo #73 and Photo #74) has a solar panel array, several AC units, a solar water heater, and water tanks. The C-clips holding the water and electrical tubes are rusted (Photo #75). There are water marks below the solar panels, however, no moisture was detected inside the property (Photo #76). There is a water bubble in one of the walls (Photo #77).
